Mech

In This Issue:

Vol. 45, No. 4 Fall 2006

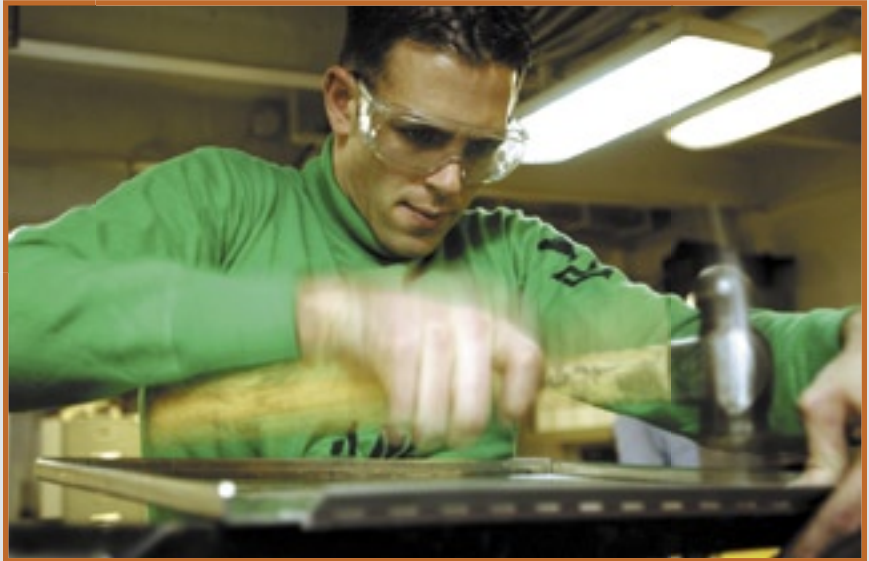
Good

Even simple tasks demand you wear protective equipment. Ask the question, what is the worst thing that could happen? And plan accordingly.

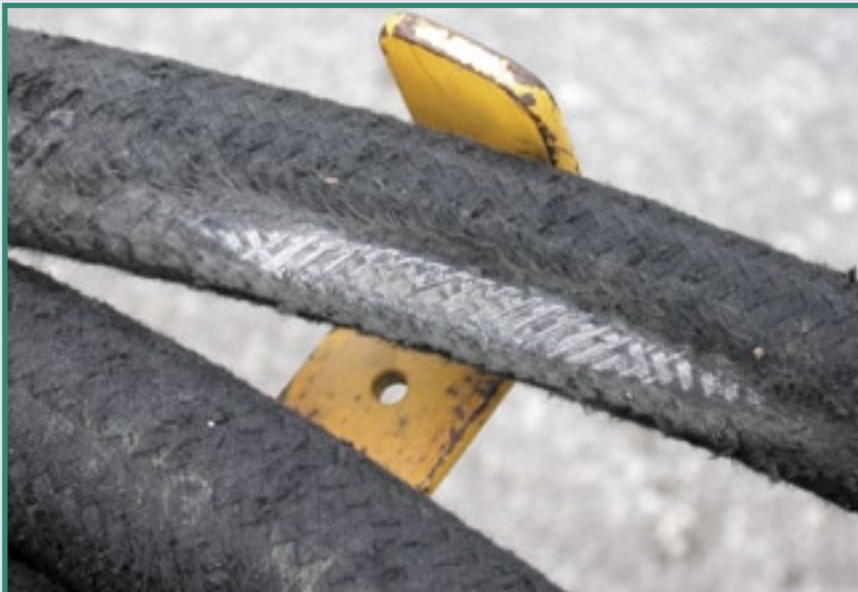
Bad

Dragging a hose while moving a cart or moving it across a rough surface can be dangerous. Check hoses before using.

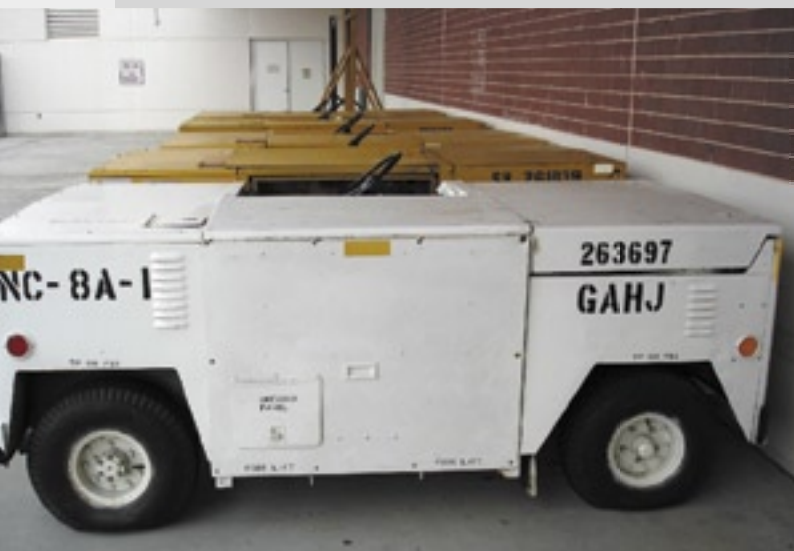
The instructors now can choose from 20 different gripes that can be installed in the trainers with the flip of a switch. With the NC-8s, an instructor had to remove certain wires to make the equipment react differently so the student would realize the unit had a problem.

Safety also has been enhanced because of the way components are laid out and the way students are required to troubleshoot. Relays, switches, resistors, cannon plugs, and various other electrical components are much more accessible to the student, eliminating most of the shock hazard. Students also are not exposed to tight quarters with moving parts, reducing the chances of a hand or arm being dragged into a moving fan blade.

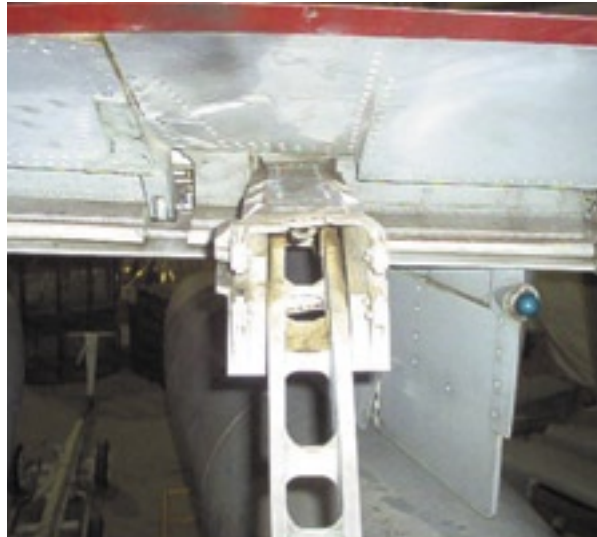
This flaperon damage was avoidable. Crew resource management is necessary in the maintenance department, too!

The ensuing inspection revealed that the forgotten or overlooked chock had crushed the flaperon. Sickened by the accident, we inspected the damage closely, expecting to find a lot more than occurred. The flaperon was the only part damaged. The most important factor is the safety of Sailors working the job, and no one had been injured.

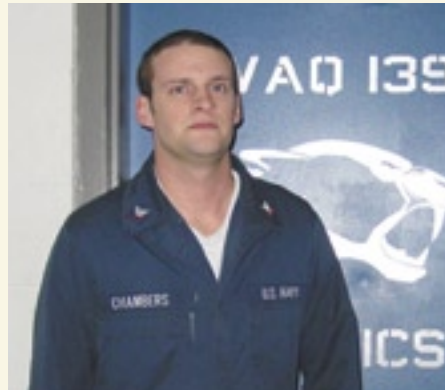
AT3 Jeffrey Chambers VAQ-139

During a routine maintenance download of pod hardbacks on Warcat 501, Petty Officer Chambers noticed a chafed wire bundle in the port engine bay. A closer look revealed these wires were part of a new weapon system.

The wiring was repaired, and the aircraft returned to flight. Had this discrepancy gone undiscovered, it would have caused significant mission degradation and could have caused an electrical fire.

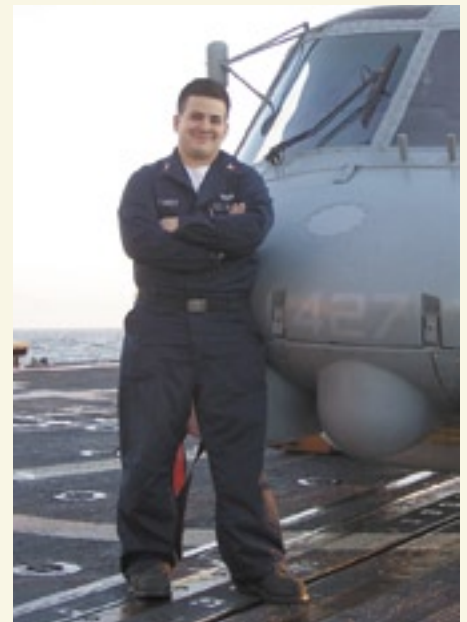
AM3 Teddy Toney HSL-42

Petty Officer Toney found a 7-inch crack in the No. 2 engine-bay door during a daily inspection of an SH-60B. The crack was located on the bottom edge of the door, was not visible from the deck, and was impossible to see once the door had been opened. Since the door is constructed of composite material, Petty Officer Toney suspected the crack might be under the surface of the paint. He continued to look and found the crack extended into the hinge-plate area. He then immediately notified his LPO.

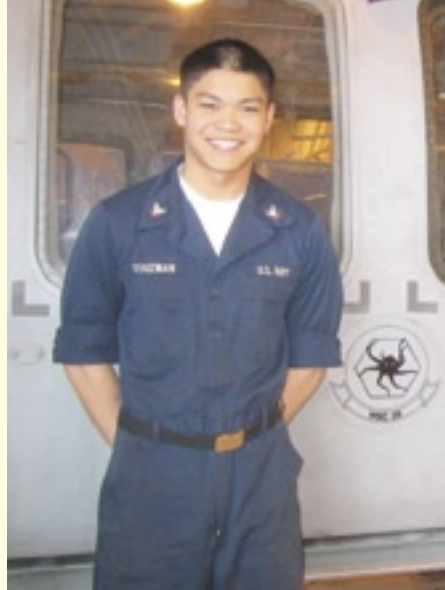
**AM3 Johnrae Deguzman
HSC-28**

While inspecting Bay Raider 43, Petty Officer Deguzman found flaking in the swashplate guide on the main rotor head and downed the aircraft until repairs could be completed.

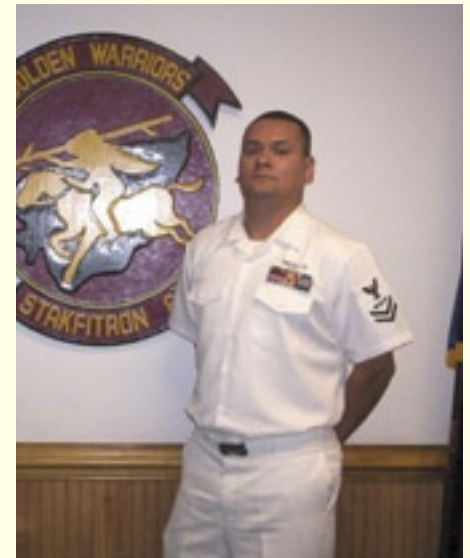
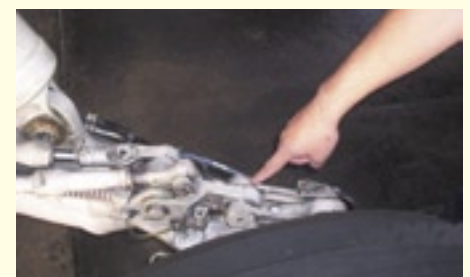
**AM2(AW) Raunel Vences
VFA-87**

While doing a serial-number verification on War Party 404 for transfer to NADEP Jacksonville, Petty Officer Vences noticed a hairline crack in the planing-arm assembly on the starboard main-landing gear. Although the transfer inspection does not require inspecting this mechanism, Vences took the extra effort and found what would have led to the failure of the starboard gear upon landing.

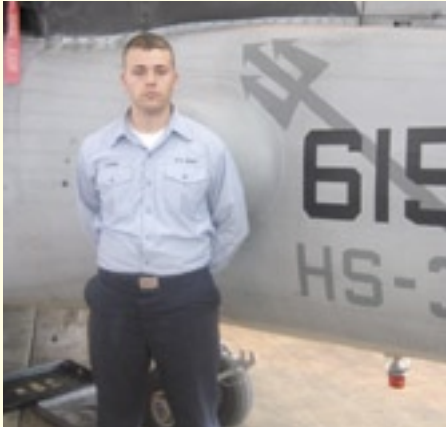
**AOAN William Turner
HS-3**

Airman Turner noticed what appeared to be grease in the area around the quick-disconnect for the viscous-dampener bearing assembly in the tail rotor. He investigated further, found the bearing had failed during the previous flight, and verified it was damaged severely.

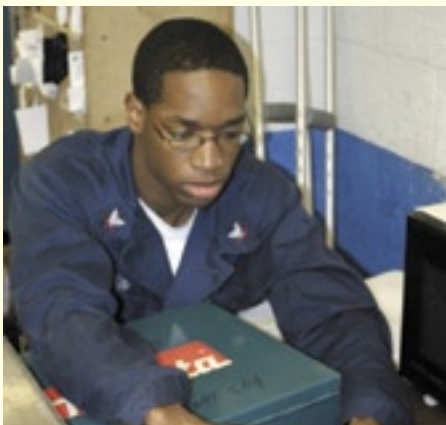
**AD3(AW) Rafael Griffin
VP-16**

On a routine daily inspection of a squadron P-3C, Petty Officer Griffin noticed the No. 4 ignition relay was hanging by the cannon plug. After notifying maintenance control of the discrepancy, he inspected further, finding the casing had separated from the mounting pad.

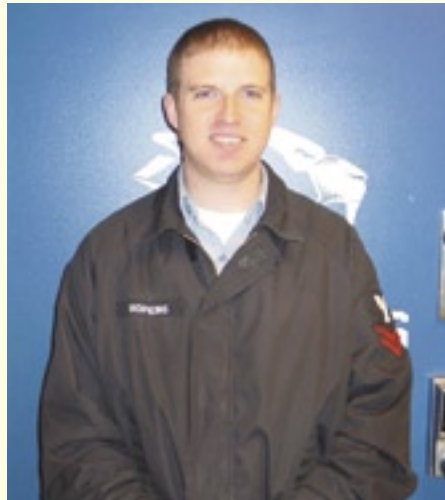
**AD2 Brett Hopkins
VAQ-139**

Before a late night turn on aircraft 500, Petty Officer Hopkins saw several new, microscopic impact marks on the first-stage compressor blades of the starboard engine. After notifying maintenance control, the engine was borescoped, and no other damage was found.

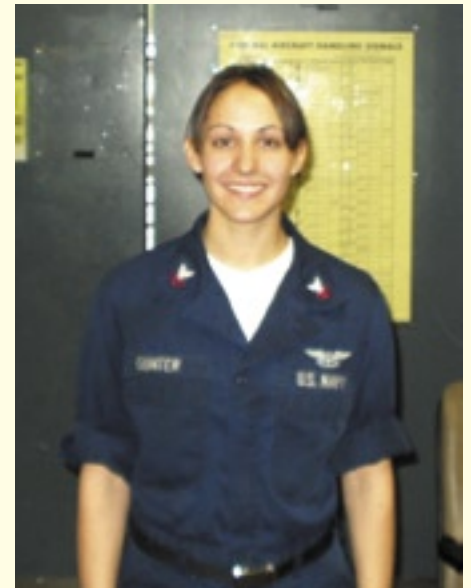
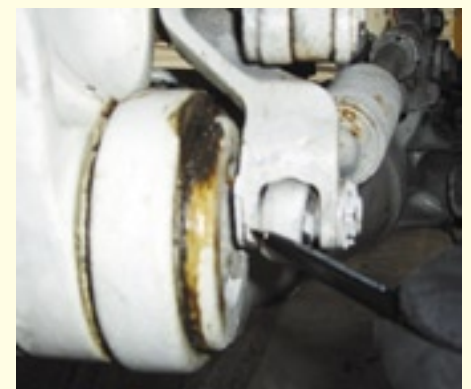
**AE2 Amy Gunter
VFC-12**

While chaining down Ambush 03 for a maintenance turn, Petty Officer Gunter saw that the head of the forward attachment bolt that connects the landing-gear crank assembly to the planing link had sheared. She notified maintenance control and downed the aircraft.
